## **FIRE EFFECT ON STEEL OF RCC STRUCTURES**

### **Abstract**

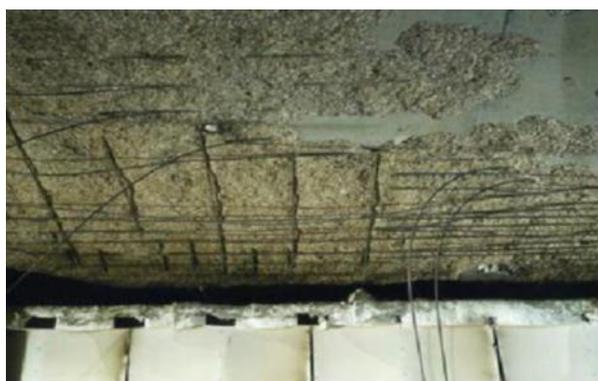
Figure 1. Fire damaged slab

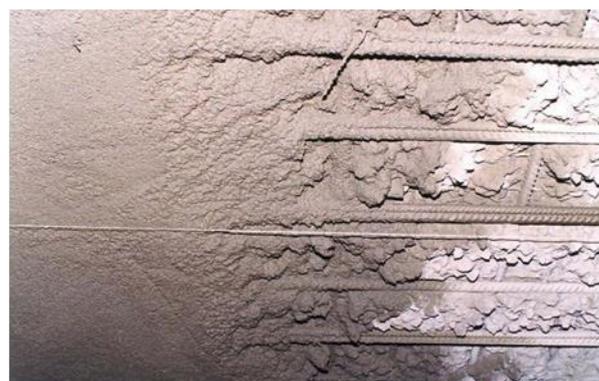
Figure 2. Concreting of fire damaged slab
